# JUNCTION BOX STATUS

CPPM, November 16th 2000

I.N.F.N. Genova

# Vessel manufacturing: final acceptance

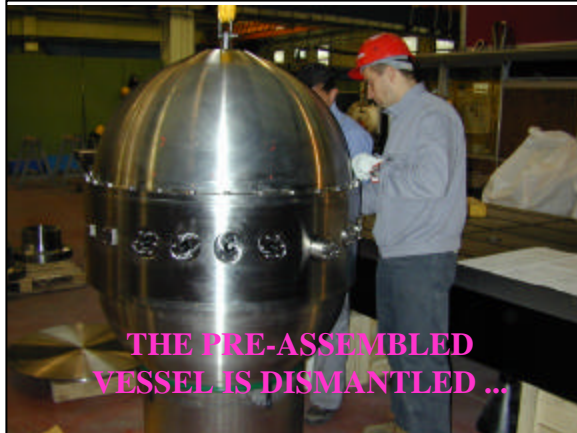
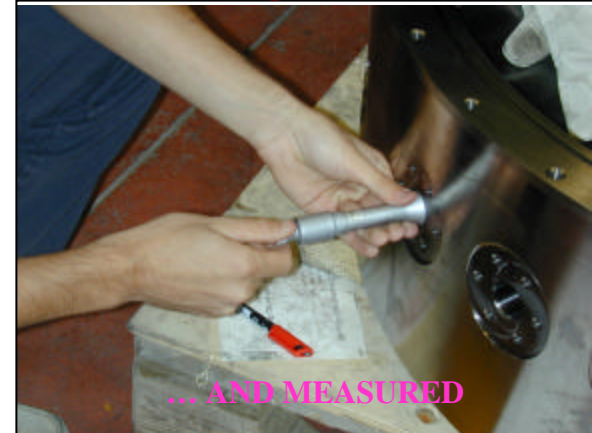
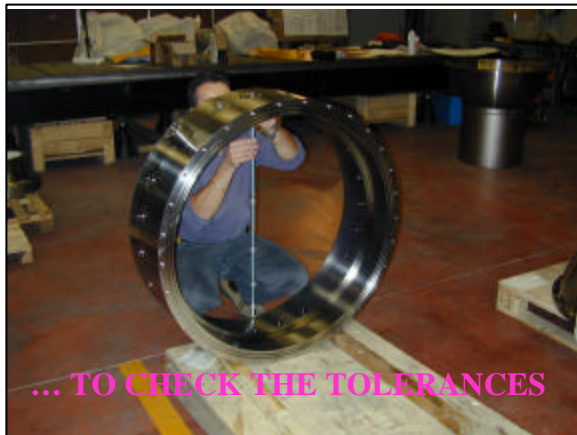
- local defaults on the diaphragm surface in contact with the O-ring: CORRECTIVE ACTION PRESCRIBED
- diaphragm thickness (17 mm instead of 15 mm): LONGER SCREWS REQUIRED
- O-ring groove depth (4.16 mm instead of 4.20 mm): O-RING SUPPLIER ACCEPTED IT
- ground anode penetrator hole larger than specified: ACCEPTED, AS DOESN'T INFLUENCE THE TIGHTNESS (ONLY FACE SEAL)
- penetrator holes roughness (1.1  $\mu\text{m}$  instead of 0.8 1.25  $\mu\text{m}$ ): ACCEPTED - RADIAL O-RING SHOULD GIVE ONLY A MINOR CONTRIBUTION TO THE GLOBAL TIGHTNESS

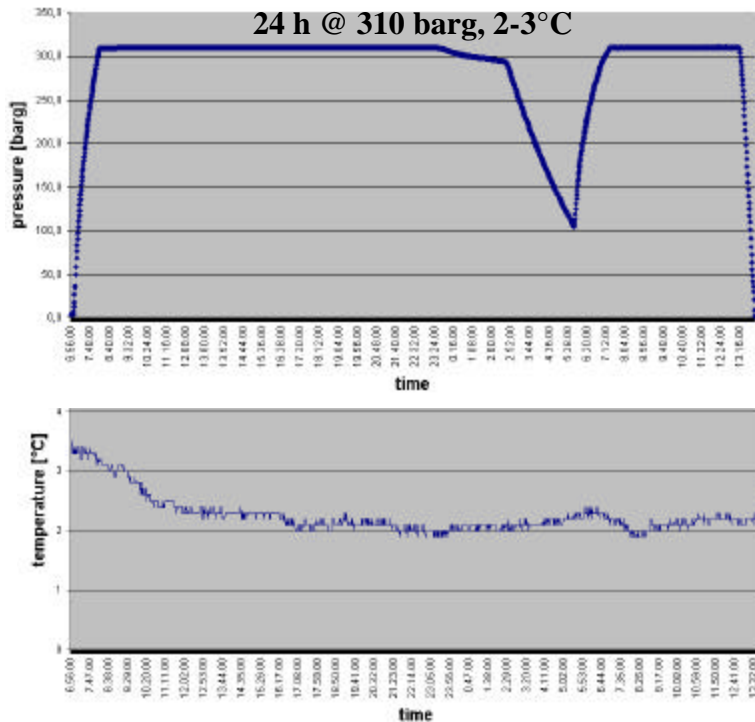
Hyperbaric static test

- static test: a temporary failure caused a pressure drop. Then we decided to extend the test in order to achieve the 24 hours @ 310 barg
- static test: we accepted the temperature to fluctuate between 2 and 3 °C

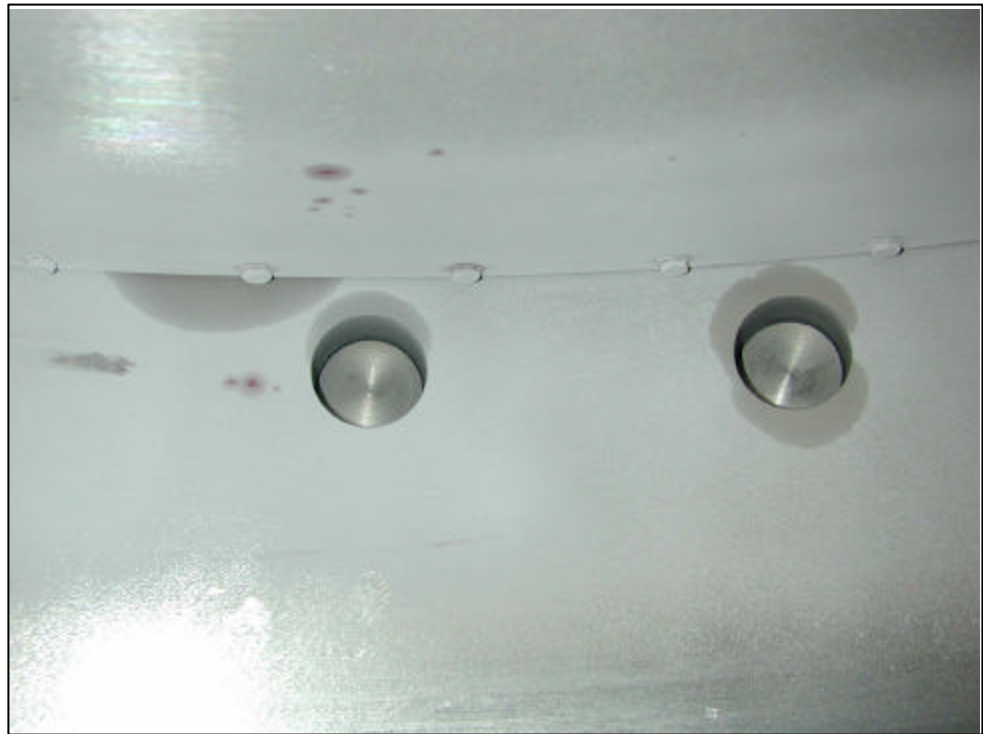
- **GEOMETRY COMPARISON:  
NO PERMANENT  
DEFORMATION DETECTED  
AFTER BOTH STATIC AND  
DYNAMIC TEST**
- **VOLUME REDUCTION OF A  
COMPARTMENT MEASURED:  
-2 dm<sup>3</sup> @ 256 barg**
- **NO MAJOR LEAKAGE  
DETECTED (INSIDE VOLUME  
SUBSTANTIALLY DRY)**
- **“SHADOW” UNDER THE  
DIAPHRAGM (IN THE O-RING  
JUNCTION AREA): MINOR  
LEAKAGE FROM THE UPPER  
COMPARTMENT?**
- **“SHADOWS” AROUND 2  
PENETRATOR HOLES:  
GREASE TRACES DIFFUSED  
IN THE DETECTING PAINT OR  
WATER FROM OUTSIDE?**

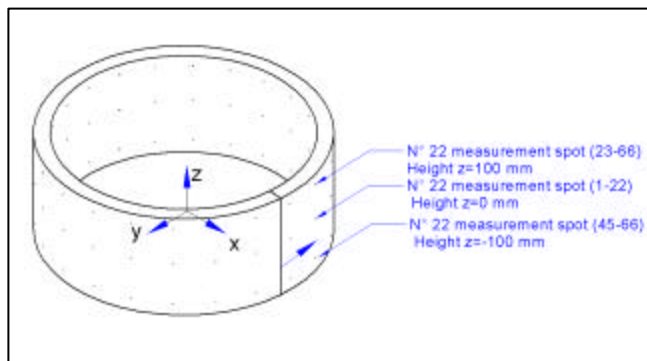
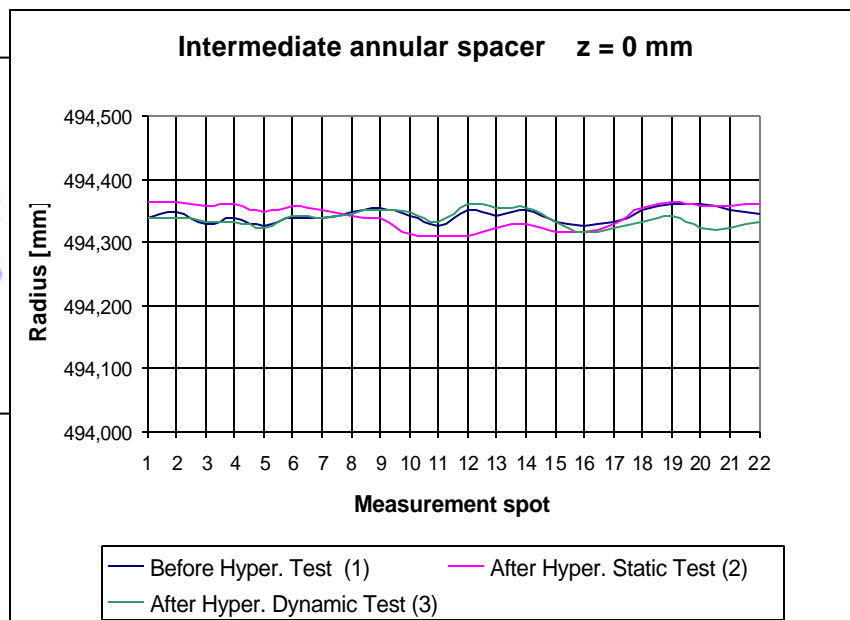
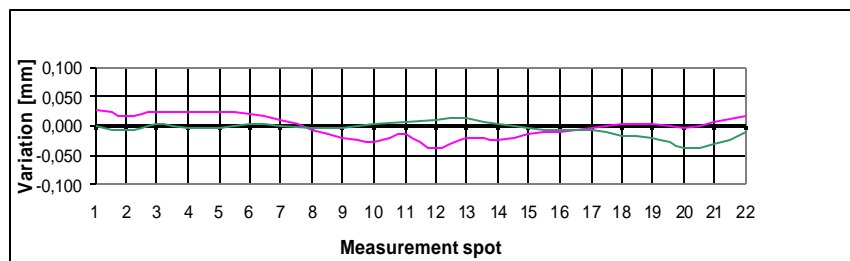
# Vessel hyperbaric tests: annulus measurements

**DEVIATIONS NOT SIGNIFICANT**

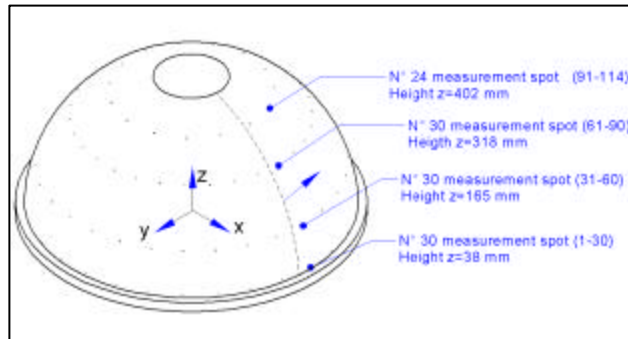
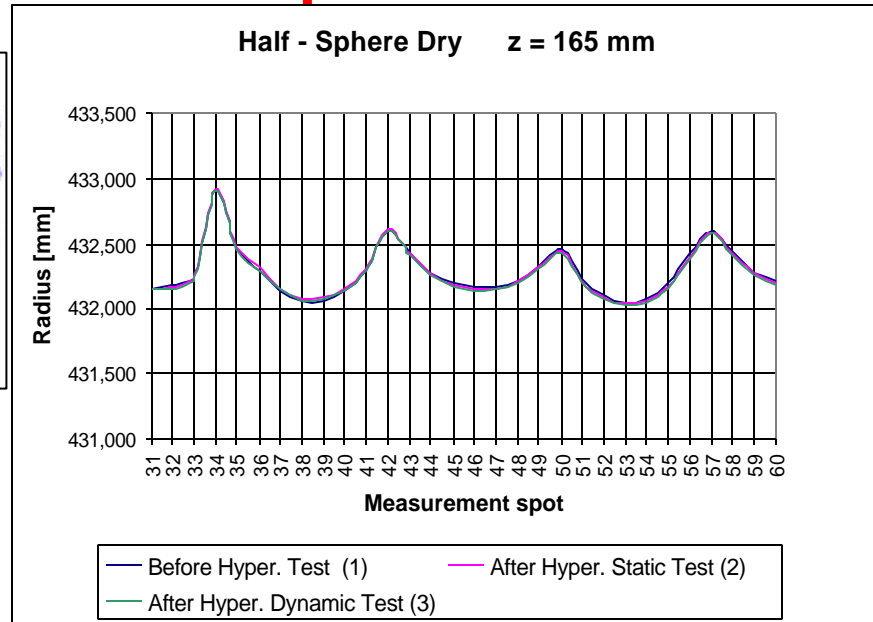
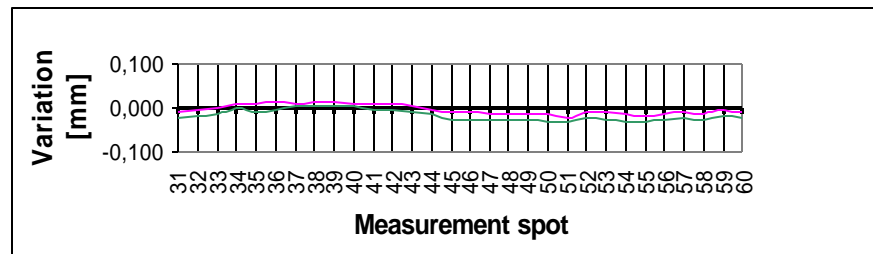
# Vessel hyperbaric tests: cap measurements

**DEVIATIONS NOT SIGNIFICANT**
