Results on 0.7% X0 thick Pixel Modules for the ATLAS Detector.

ATLAS Pixel Modules.

ATLAS Pixel Module Components.

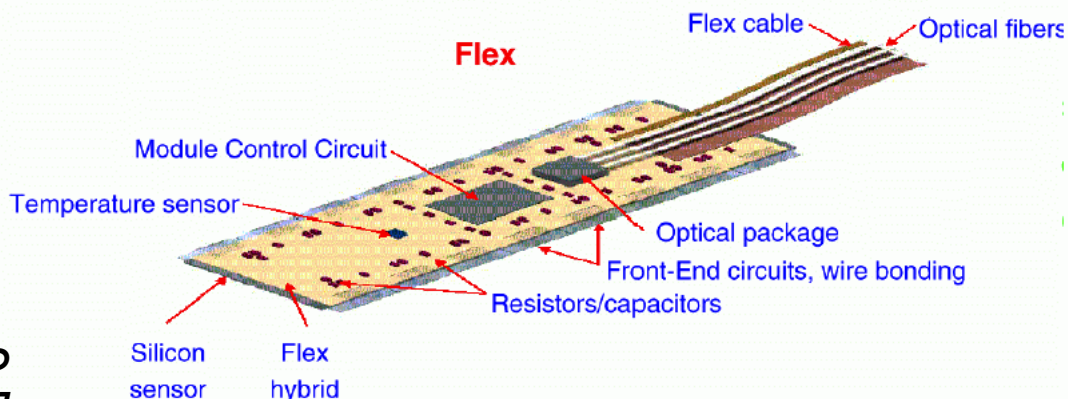
- **Silicon Sensor**
- Kapton **Flex-hybrid** glued to the **Sensor** (talk of F.Huegging)
- 16 **FE chips** bump-bonded to the **Sensor** and wire-bonded to the **Flex-hybrid**
- **Module Control Circuit (MCC)** wire-bonded to the **Flex-hybrid**
- **Passive components** including termination resistors, decoupling capacitors and temperature sensor
- **Pigtail** - bus lines routing signals to/from MCC

First prototypes did not have optical connections or Flex power connection and have been mounted on PC boards for testing.

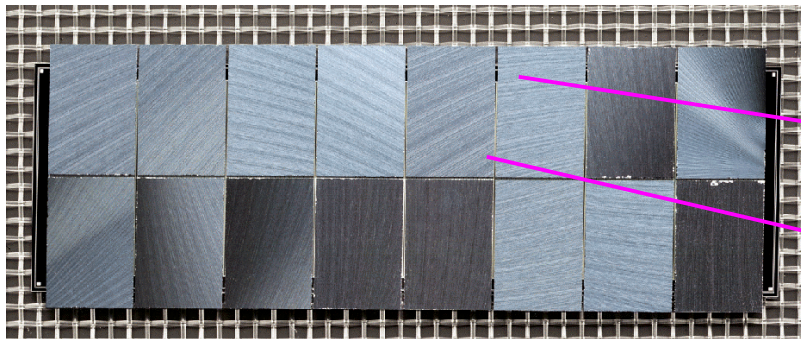
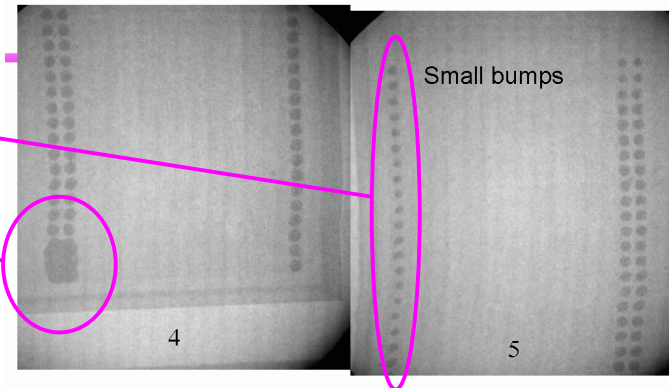
X-rays test of assembly FE chips + Sensor (bare Module)

*X-rays test -
2 μ m resolution radiography:
some bump problems are visible*

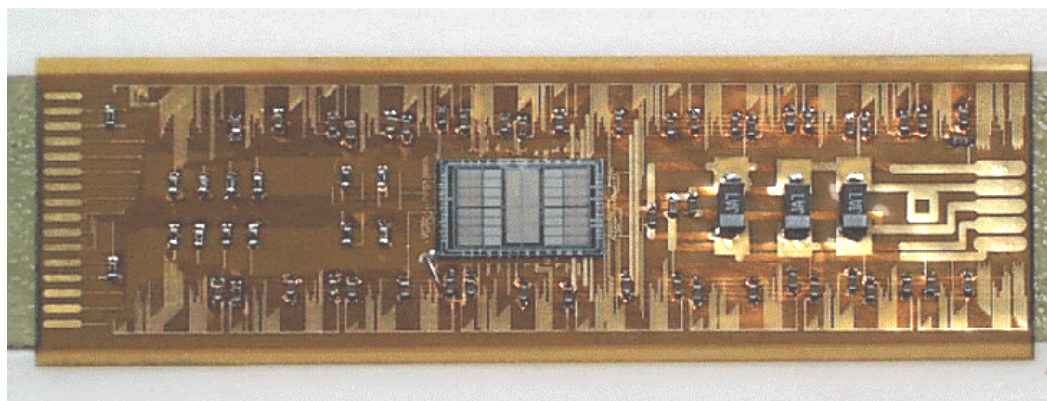
Test of Flex-hybrid itself: flying probe test

Mounting of passive components on Flex-hybrid and test

Mounting and wire-bonding of MCC to Flex-hybrid

*Flex-hybrid test with mounted components:
voltages, read/write MCC registers*

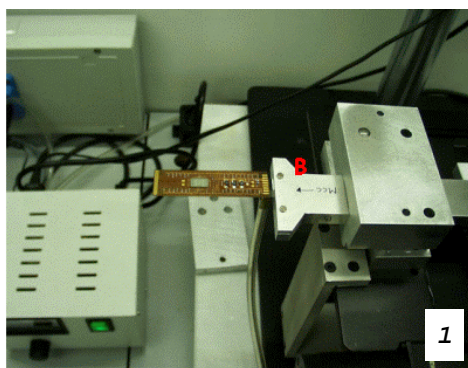
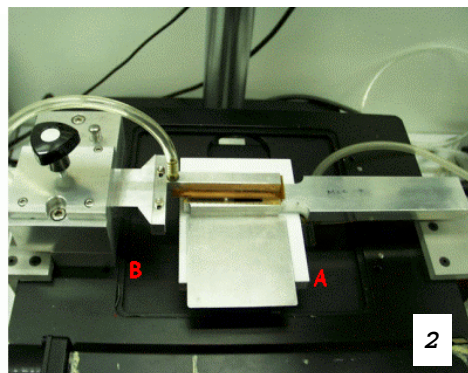
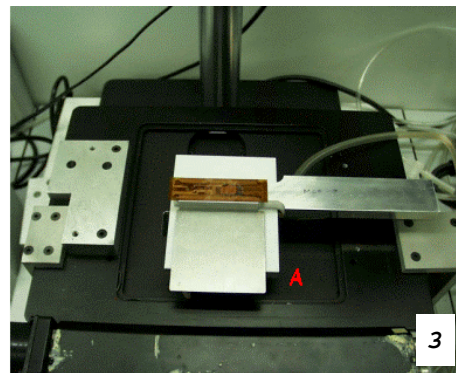
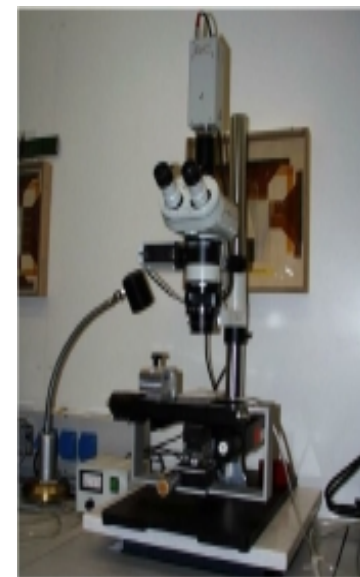
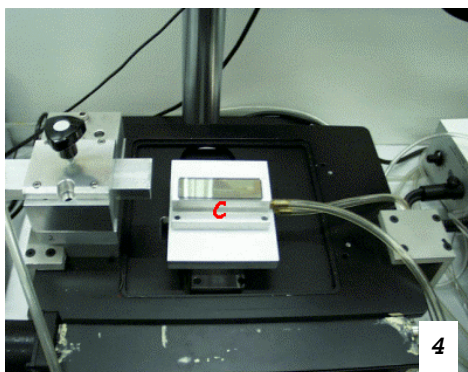
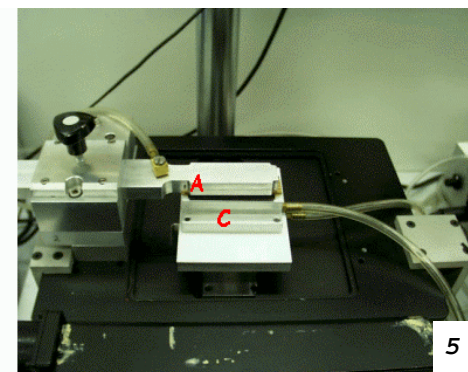
Gluing Flex-hybrid to the bare Module

Flex-hybrid is being fixed on the special profile plate (3) not to damage wire-bonded MCC and components. Glue (EPOTEK 353) is being deposited corresponding to FE pads and under MCC. Optical alignment between Sensor and Flex-hybrid is being performed (5). Glue polymerization with infrared lamp (40 C, ~12 hours).

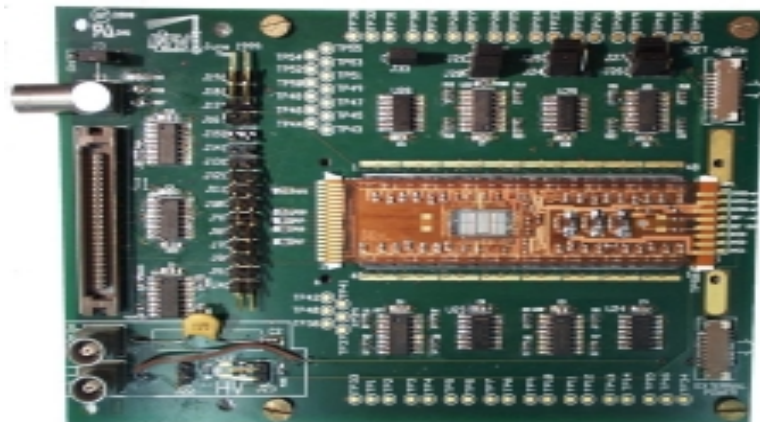
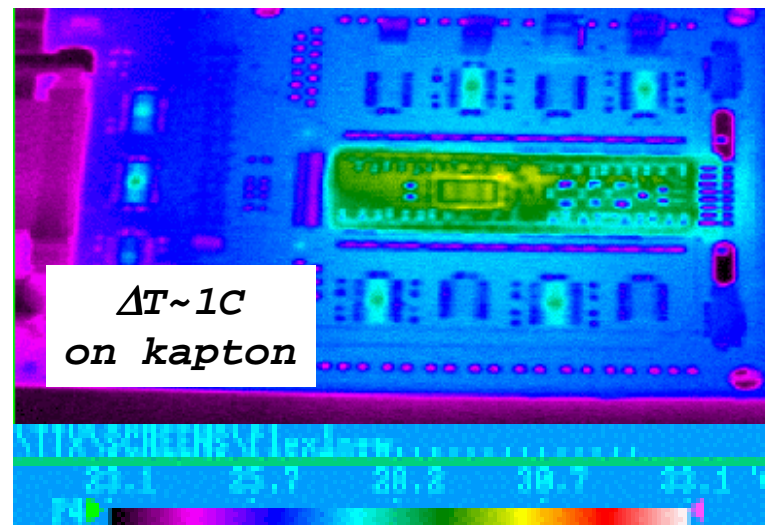
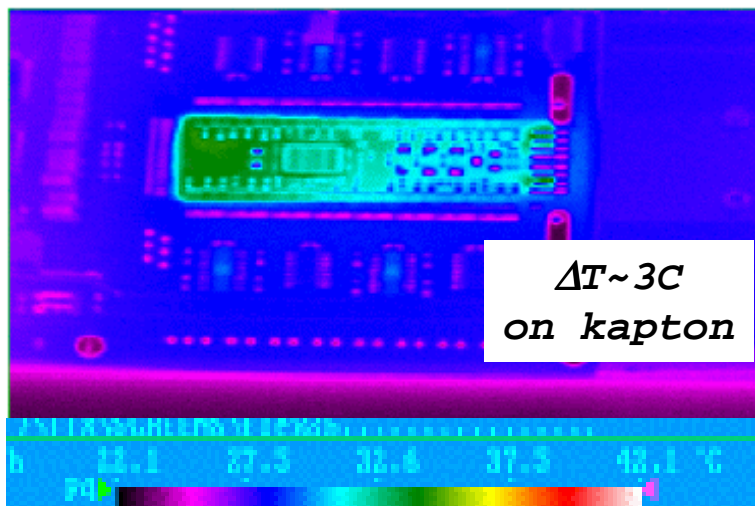
Gluing to Support Card and Thermocamera test

Module is being glued to the Support Card with silicon glue (Dow Corning, 20 C, 24 hours).

Thermal contact and thermal uniformity are being tested with thermocamera on module in operation.

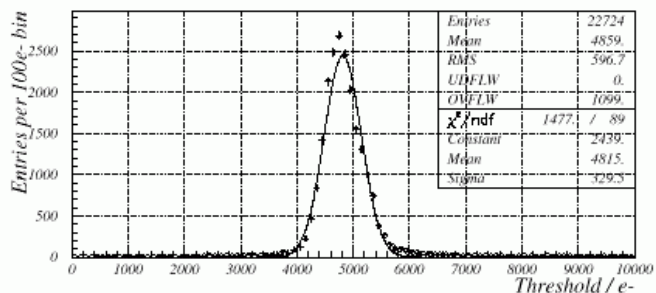
Thresholds were about 4800e.

3 FE chips were very noisy, by switching them off high noise (>500e) tail had disappeared.

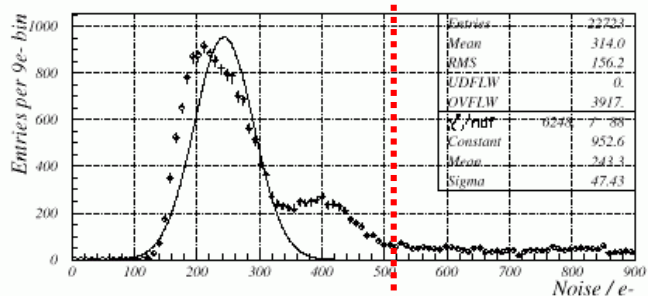
"Good" chips had mean noise value of about 270e.

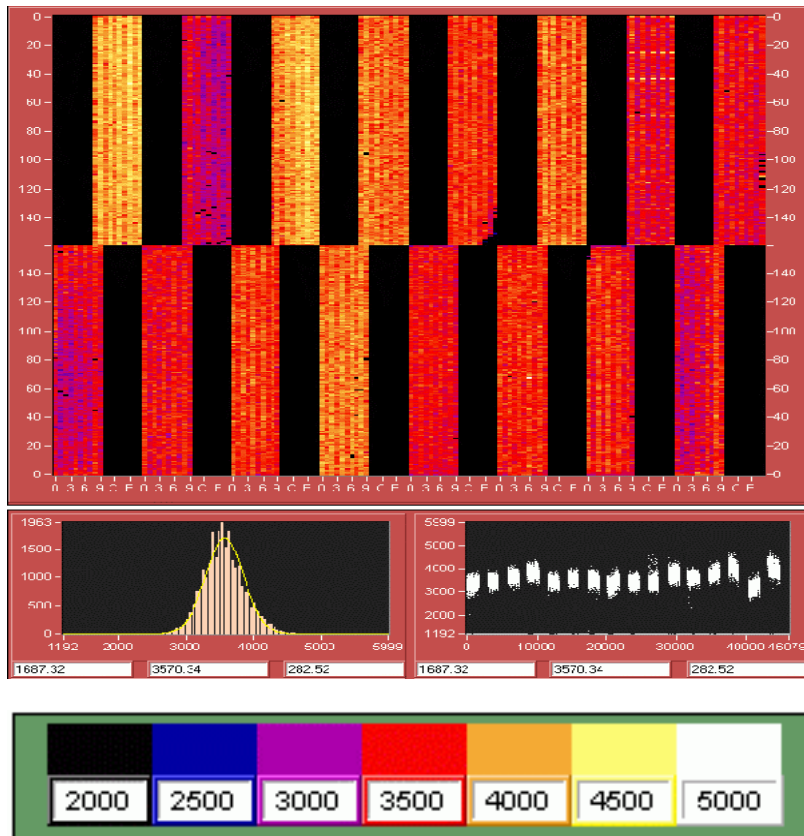
Threshold plot.

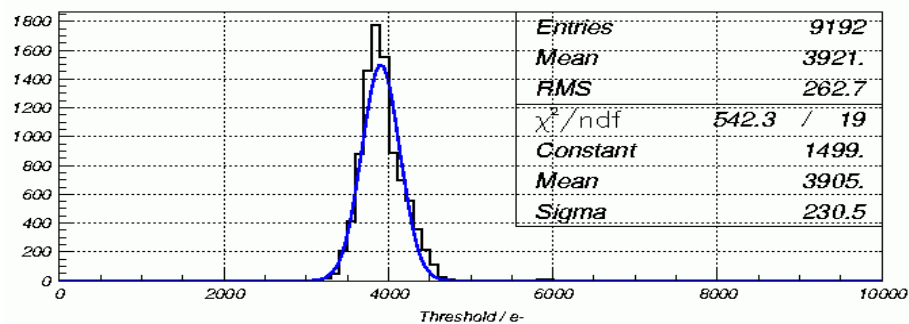
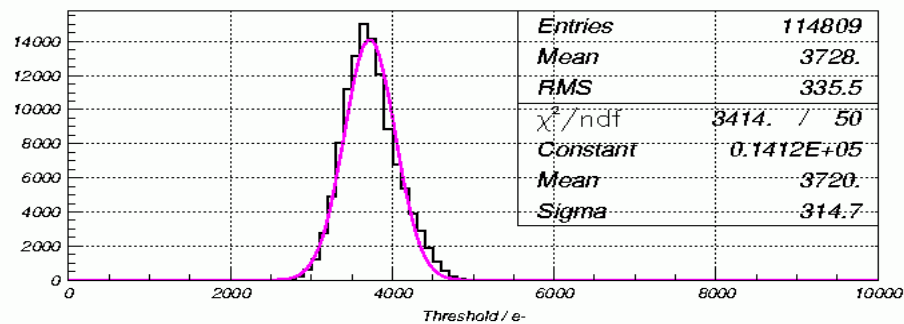
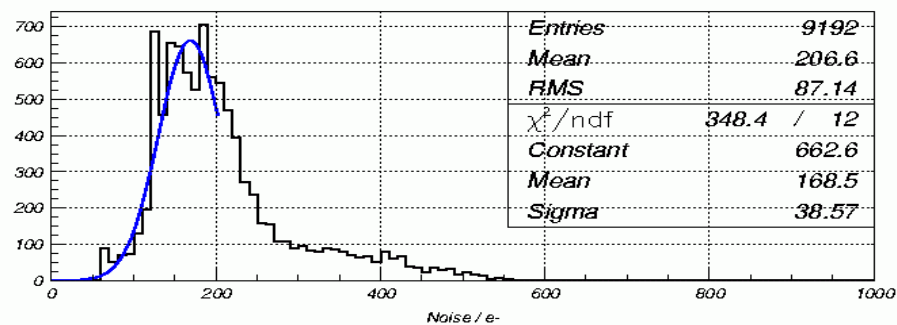
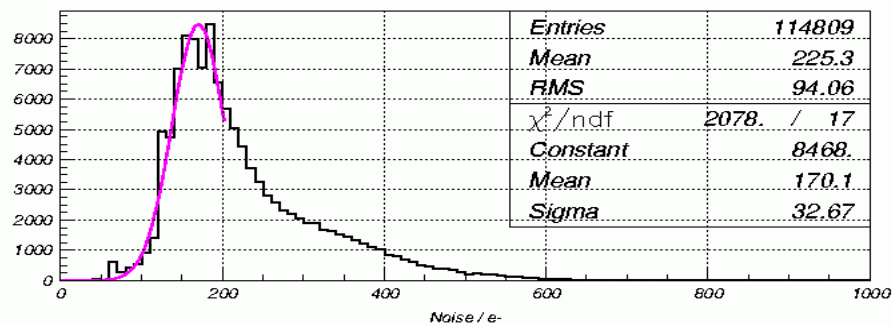
Thin Module 2: Mean values for 16 FE-s

1 measurement

✿ Threshold $3900e \pm 260e$

✿ Noise $\sim 210e$

10 measurements

✿ Threshold $3700e \pm 300e$

✿ Noise $\sim 225e$

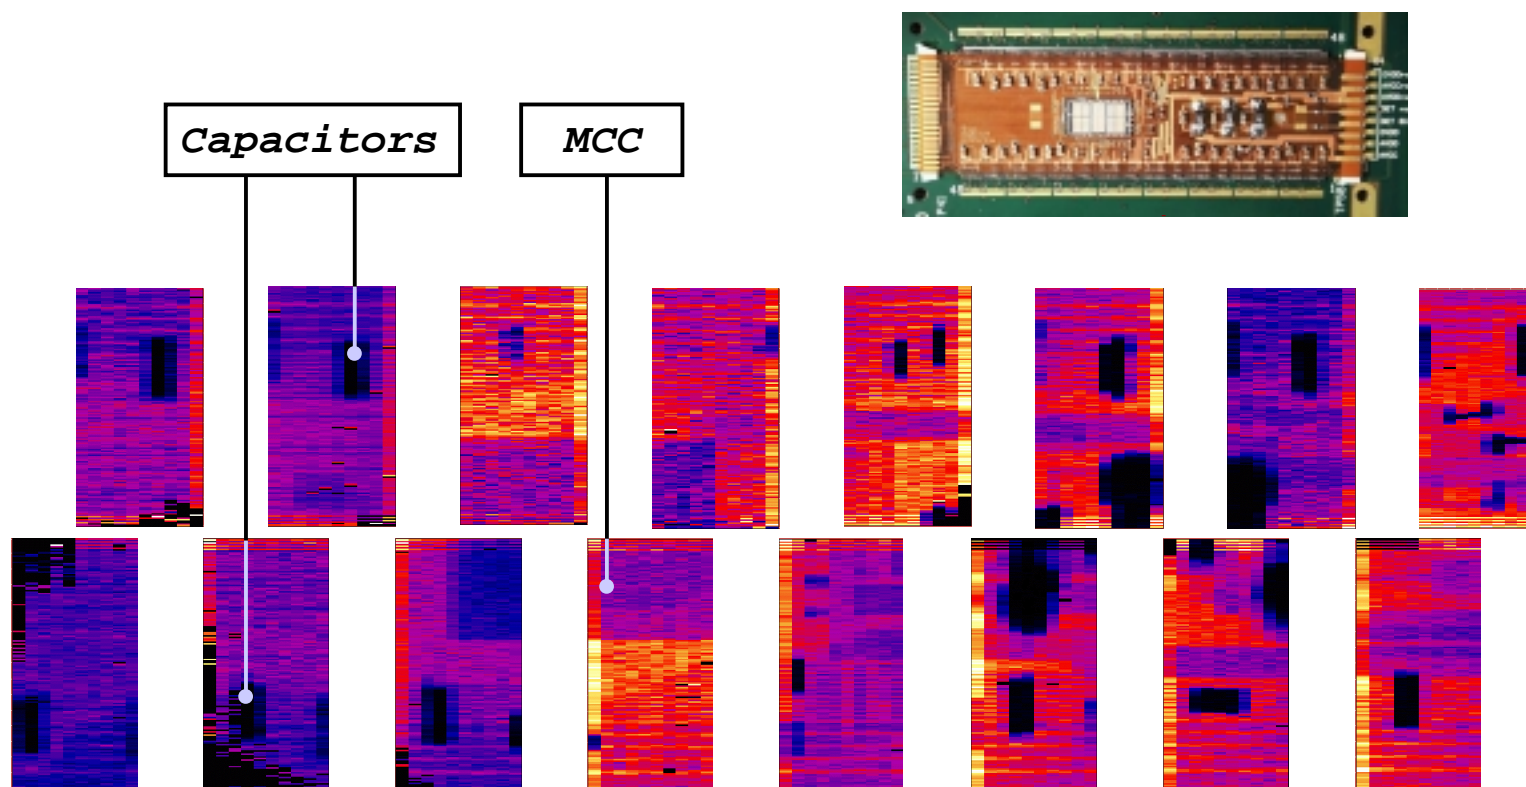
Thin Module 2: Source (^{109}Cd) tests.

MCC and electronic components are visible.

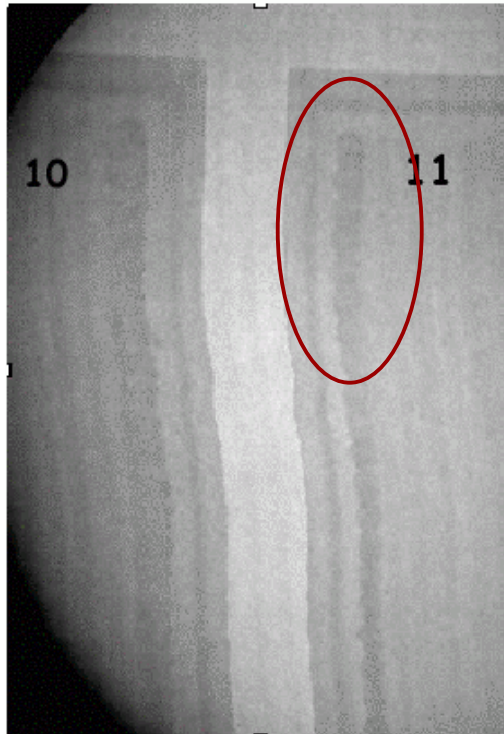
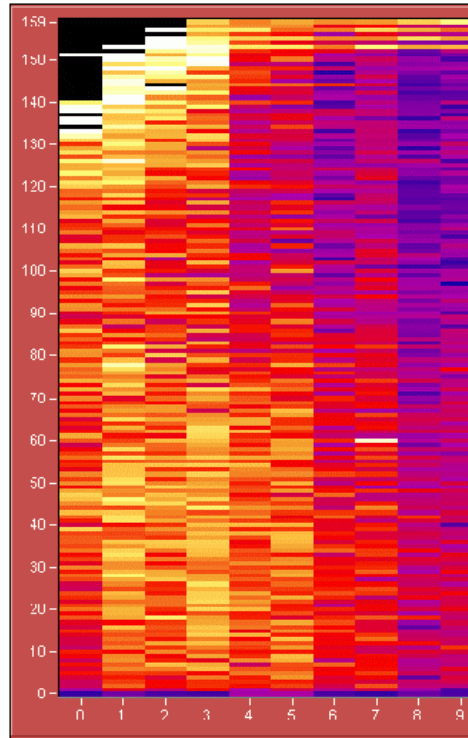
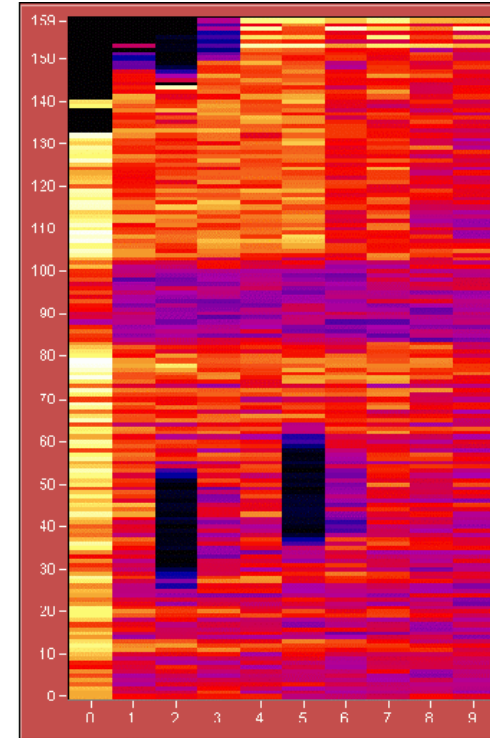
Thin Module 2: micro-radiography analysis of defects.

X-rays

Noise

Source scan

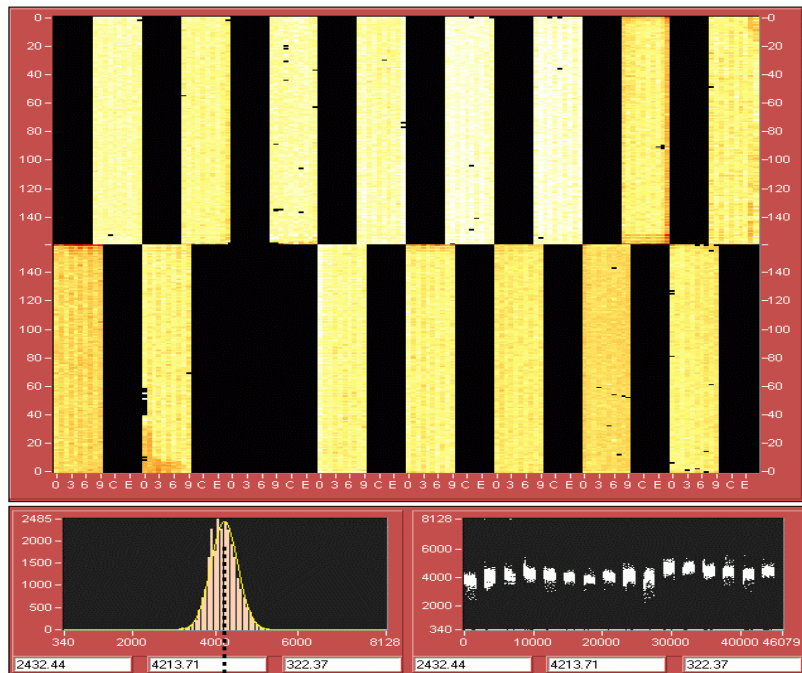
$4200e \pm 330e$

Threshold plot.

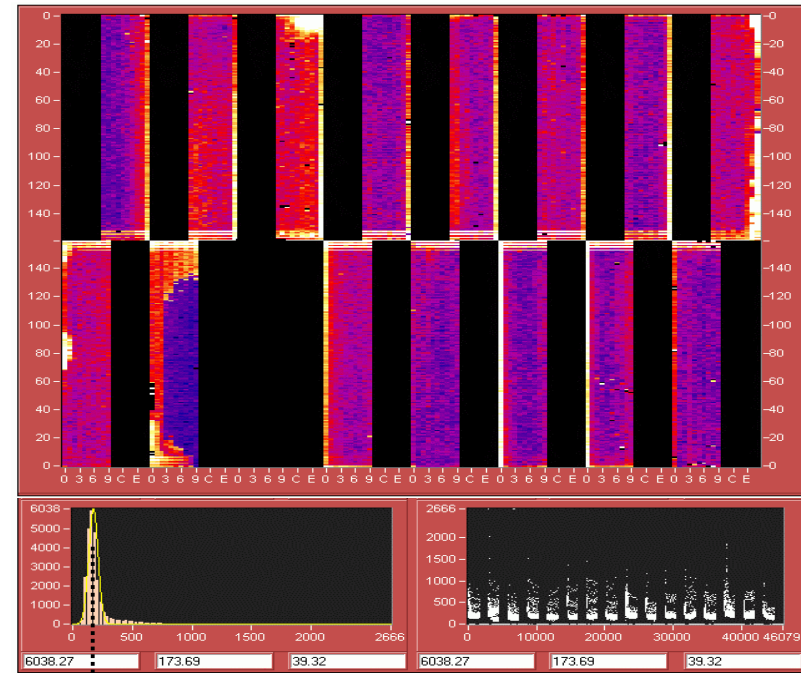
180e

Noise plot.
FE#1 - detached bumps

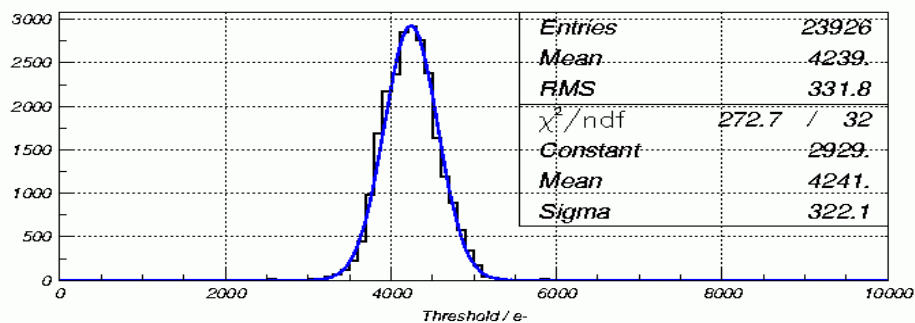
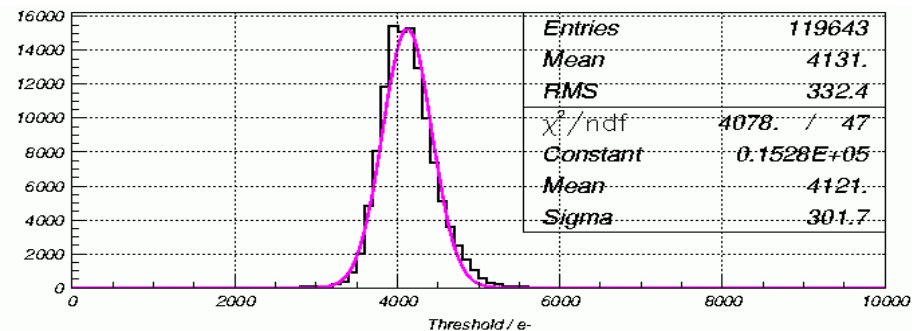
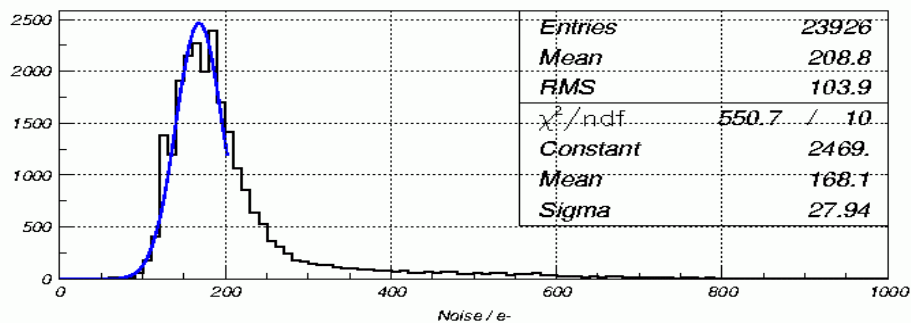
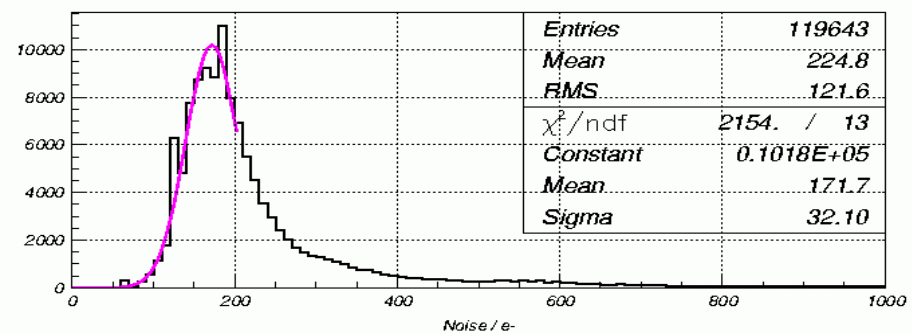
Thin Module 3: Mean values for 16 FE-s

1 measurement

✿ Threshold $4200e \pm 330e$

✿ Noise $\sim 210e$

10 measurements

✿ Noise $\sim 225e$

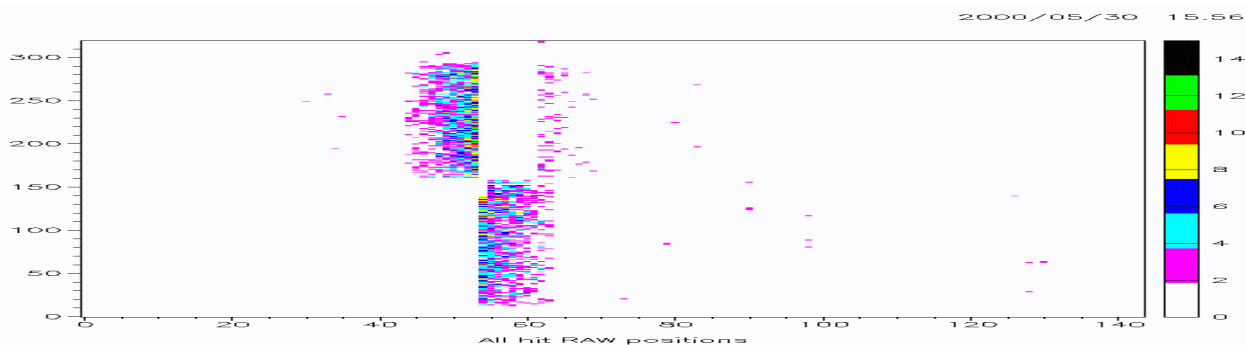
Online plots:
beam spot

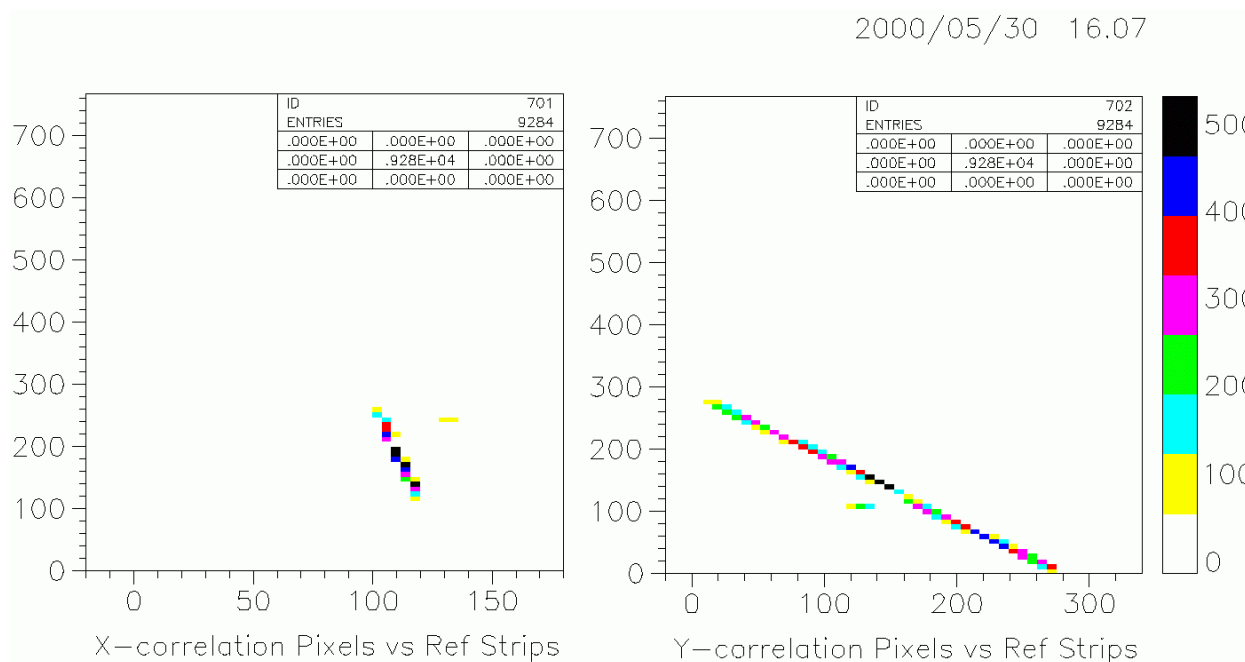
Online plots:
Module \leftrightarrow Beam
microstrips
data correlation
